Failure Analysis of Cam gear & Auxiliary gear

A.M.Tripathi

Department of Mechanical Engineering, A.I.M.T., Greater Noida, India

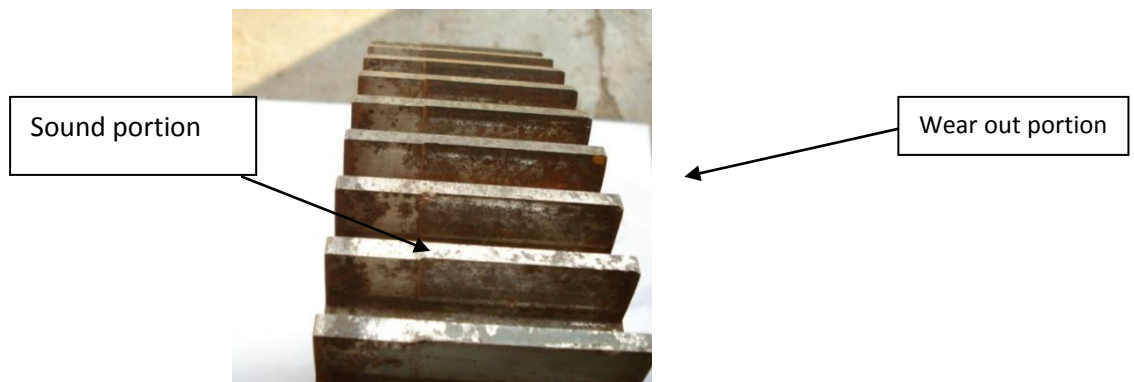
Sample No. 232/09/1 (Cam Gear)

The top portion of cam gear was found worn out partially to a length of 51.5 mm and up to a depth of 0.5 mm in all the teeth as shown in (fig.1)

Fig.1 photograph showing wear teeth of cam gear

The findings indicate that medium carbon chromium alloyed steel having the ability to harden throughout the section was used for cam gear. This gear was found to be through hardened where the hardness varied from 41-38 HRC. The findings in respect of auxiliary gear reveal that a low carbon, Ni-Cr alloyed steel of case carburising quality was used for manufacturing auxiliary gear and the gear was found to be case hardened up to the depth of 1.20 mm with the surface hardness of 51 HRC. Thus, the cam gear with a surface hardness of about 41 HRC on the teeth and the auxiliary gear with the surface hardness of 51 HRC on teeth were mating each other during service. However, the wear on the top surface of all the teeth of cam gear covering partial length shows some mismatch between the two. Had the difference in hardness and chemical composition been the predominant factors for wear of cam gear, the gear should have been worn out on the entire surface and length of all the teeth.

1. The partial wear on up to certain length of all the teeth of cam gear may be attributable to the combined effect of mismatch between the mating gears and lower hardness of cam gear as compared to the auxiliary gear.
2. It is advised to modify the heat treatment of cam gear so as to approximately match the teeth hardness with the mating auxiliary gear. The cam gear made out of medium carbon chromium alloyed steel can be subjected to hardening and tempering in the core and induction hardening in the teeth to achieve about 30-35 HRC in the core and 40+5 HRC in the case of teeth.
3. The fitments aspects need to be looked into so as to avoid wear due to mismatch of gears.

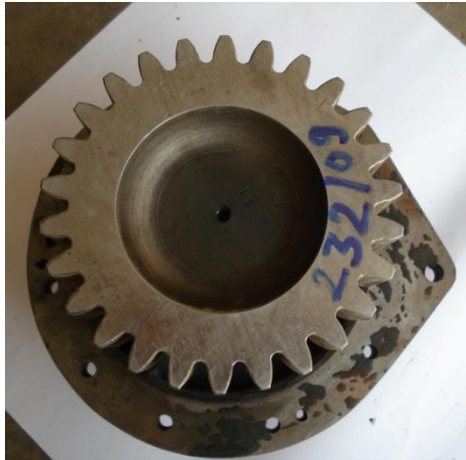
Sample No. 232/09/2:

There was not any deformation or breakage noticed in this sample. Gear was received in assembled condition.

Fig.2 photograph showing auxiliary gear.

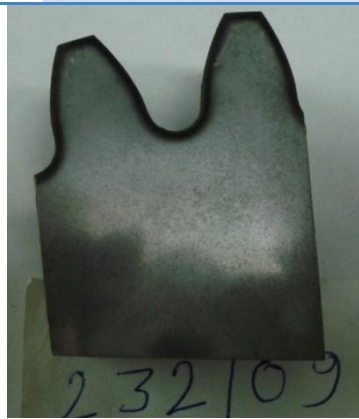
| Sample No. | Case Depth (mm) | Specified |
|---|---|---|
| 232/09/2 (auxiliary gear) | 1.2 | Not specified |

Fig.3 Photograph showing case depth of sample no.232/09/2.

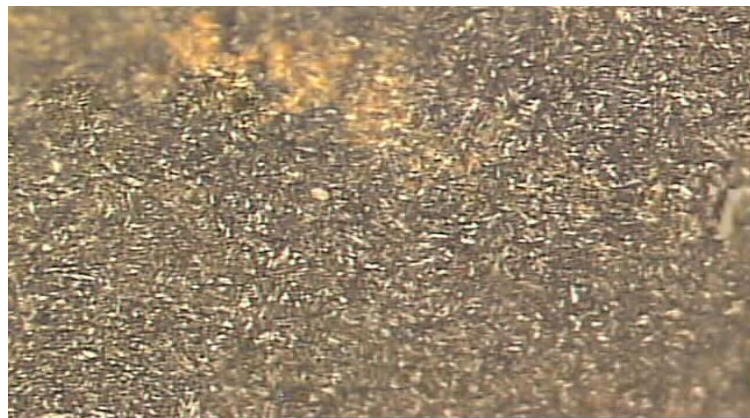
| Sample No. | Observation |
|---|---|
| 232/09/1 (cam gear) | Revealed tempered martensite (fig.4) |

Fig.4 Photomicrograph showing tempered martensite structure in X500 sample no.232/09/1 (cam gear).

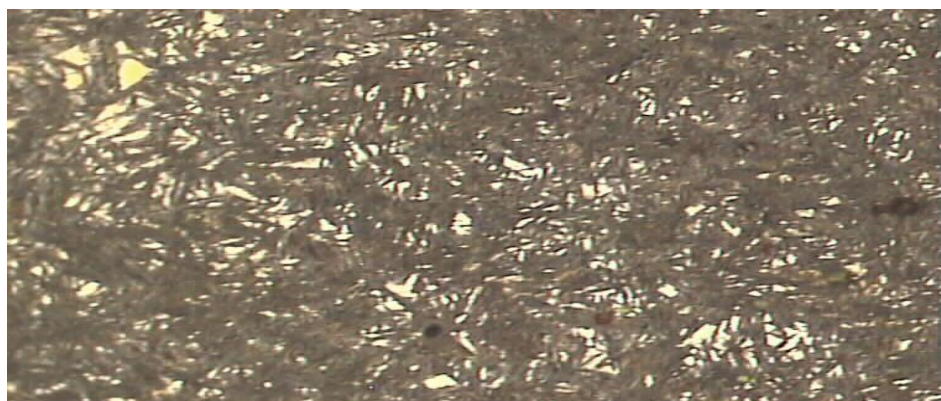
| Sample No. | Observation |
|---|---|
| 232/09/2 (auxiliary gear) | Case – Revealed martensite (fig.5). Core – Revealed mixture of bainite and martensite. (fig.6).. |

Fig.5 Photomicrograph showing martensite in the case of X500 sample no.232/09/2 (auxiliary gear).

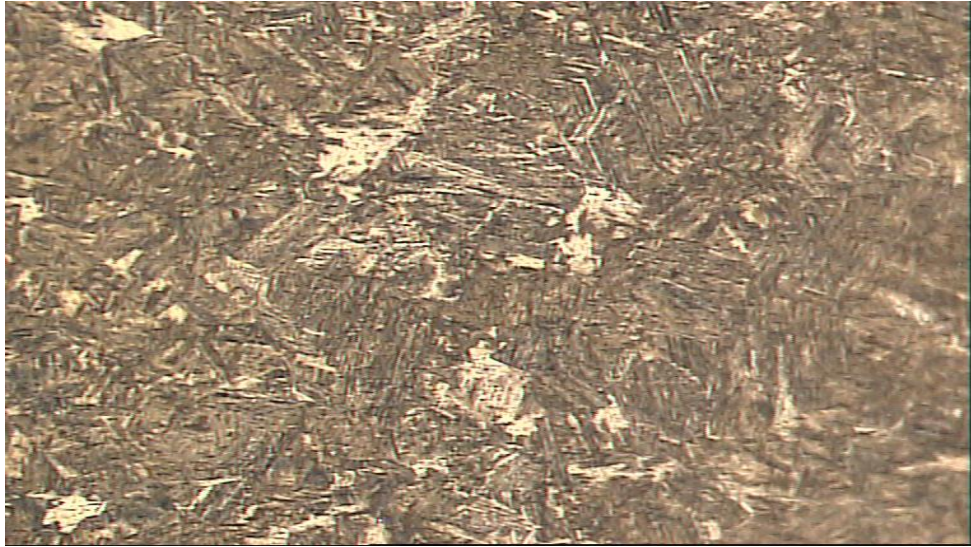
Fig.6 Photomicrograph showing mixture of bainite & martensite X500 in core of sample no.232/09/09/2 (auxiliary gear).
