MONITORING CORROSION RESISTANCE IN BRIDGE DECK REINFORCING STEEL: FIELD INVESTIGATION

ABSTRACT

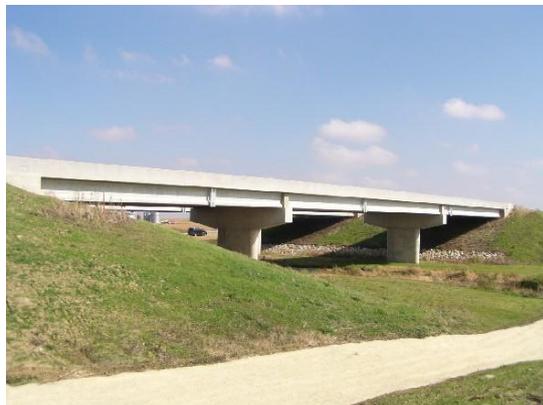
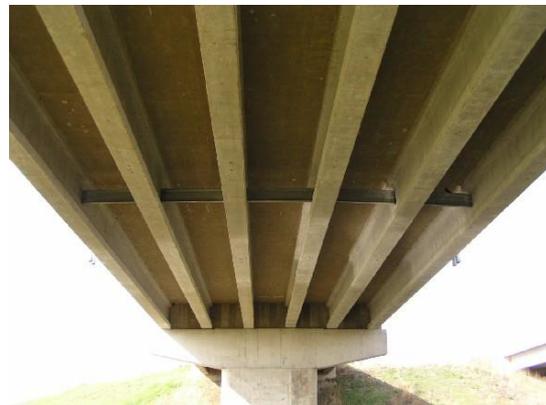
(a) Side view

(b) Bottom view (center span and west pier)

Figure 1 – Photographs and general framing plan of bridges.

The subject bridges (Fig. 1) are located on US 20 over South Beaver Creek in Grundy County, Iowa. The twin bridges are three-span prestressed girder bridges with 83.5 m (274 ft) in total length consisting of two 24.75 m (81.20 ft) end spans and a 34 m (111.55 ft) center span. The primary members of the bridges consist of six prestressed concrete beams spaced at 2,200 mm (7.22 ft) on center. The bridge deck is a nominal 200-mm (1-in.) thick cast-in-place, reinforced concrete slab that includes a 13-mm (1/2-in.) integral wearing surface. The roadway width is 12 m (39.37 ft) allowing two traffic lanes with a narrow shoulder on each side. The decks of the two bridges were constructed with two different types of reinforcing steel; MMFX steel in the eastbound bridge, referred to as 'MMFX bridge' (Fig. 1c) and epoxy coated steel in the westbound bridge, referred to as 'Epoxy bridge' (Fig. 1d). There was essentially no difference in how these two bridges were constructed. The top transverse reinforcing steel was placed parallel to and 65 mm (2.56 in.) clear below the top of the slab while the bottom transverse reinforcing steel was placed parallel to and 25 mm (1 in.) clear above the bottom of the

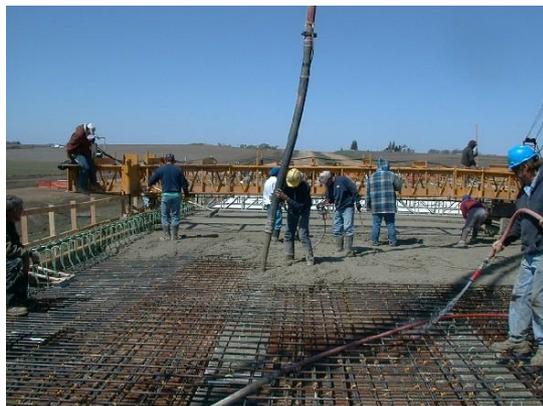
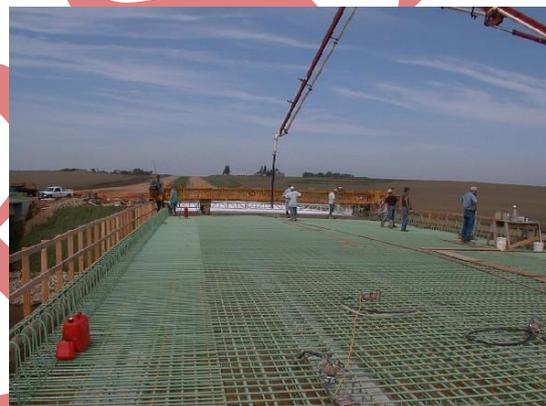
(c) 'MMFX bridge' deck concrete placement

(d) 'Epoxy bridge' deck concrete placement

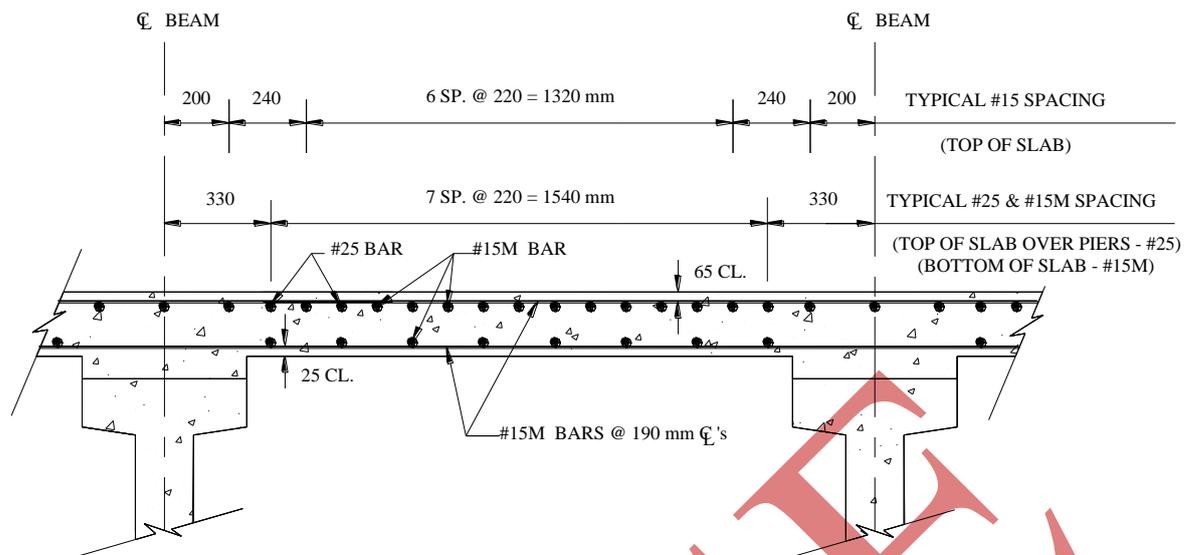
Figure 2 - Typical cross section of bridges.

slab (Fig. 2). Approximately 50 mm (2 in.) of clear distance from the face of concrete to near reinforcing steel was used. All slab and diaphragm reinforcing steels were tied in place and adequately supported before the deck concrete was poured. The pier and abutment diaphragm concrete was placed monolithically with the floor slab. Moderate curbs were constructed integral with the deck and concrete guardrails connected to the curbs.

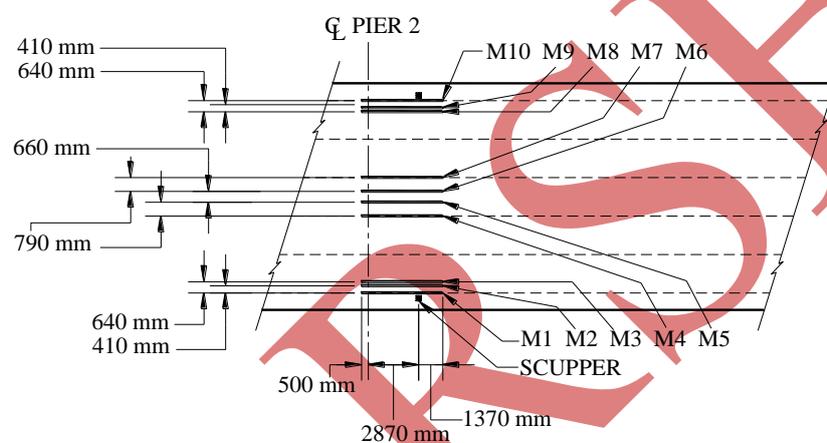
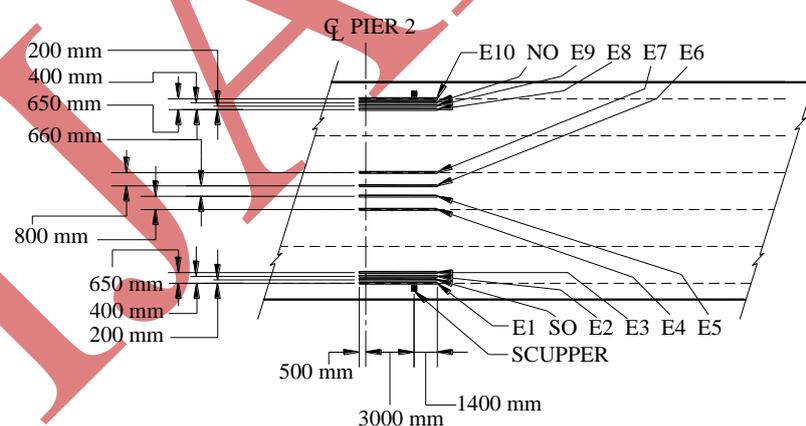
(a) MMFX bridge

(b) Epoxy bridge

Figure 3 –General instrumentation of silver-silver electrode sensors.

Both bridges were instrumented with the sensors permanently embedded in the concrete deck. A total of twenty No. 25 (ASTM) top reinforcing steels (10 sensors on each bridge – M1 through M10 on MMFX bridge, and E1 through E10 on Epoxy bridge) in the negative bending moment region near the eastern drainage points were instrumented (Fig. 3). Each sensor was wound around the length of approximately 4.6 m (15 ft) of each reinforcing steel and then connected to a red lead wire with a protected butt splice (Fig. 4). A black wire is then attached directly to the reinforcing steel using a stainless steel clamp. These lead wires were run out of the deck and were used to measure internal voltage and electrical current to assess corrosion development. On the Epoxy Bridge, two additional short sections of MMFX steels were instrumented with electrodes and placed between other epoxy coated steels (i.e., one on the north side - referred to as 'NO', and one on the south side - referred to as 'SO') to compare with the epoxy steels within the same environment.

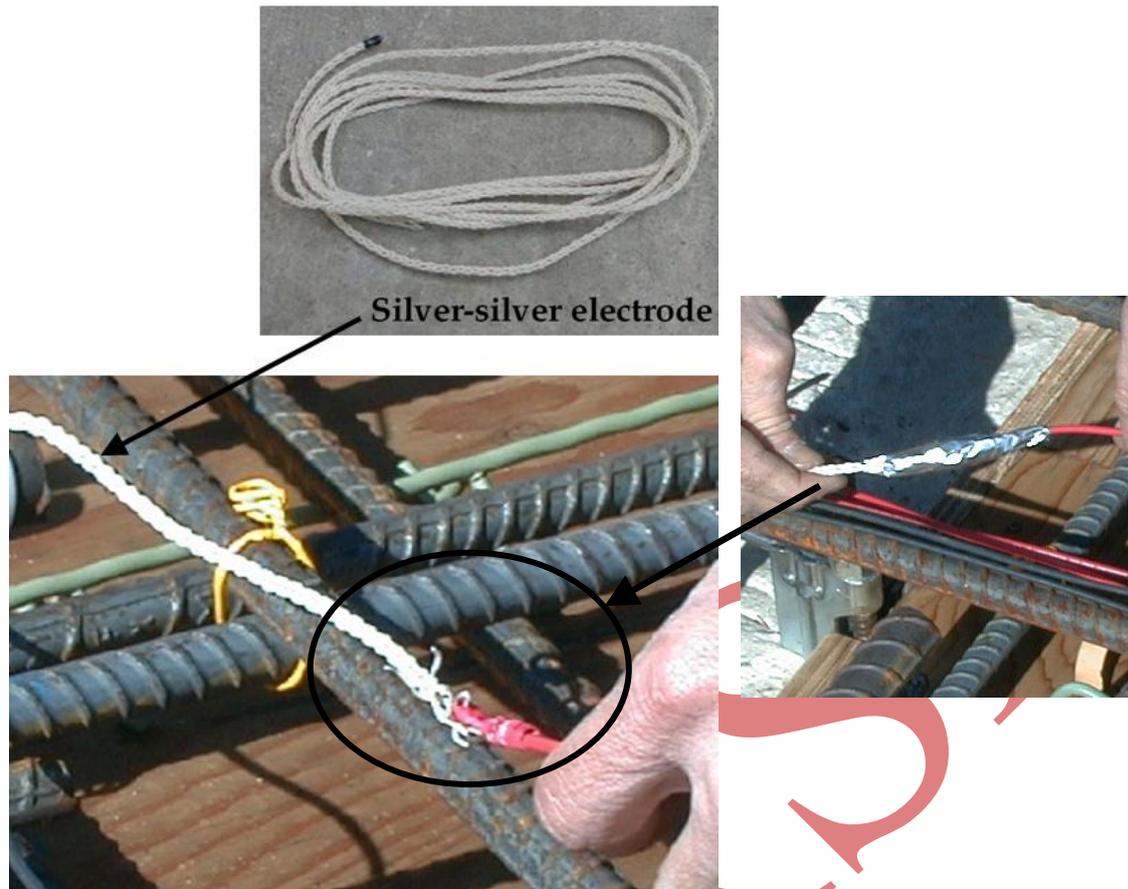
Figure 4 - Electrode sensor butt-spliced and protected with butyl rubber and aluminum-foil.

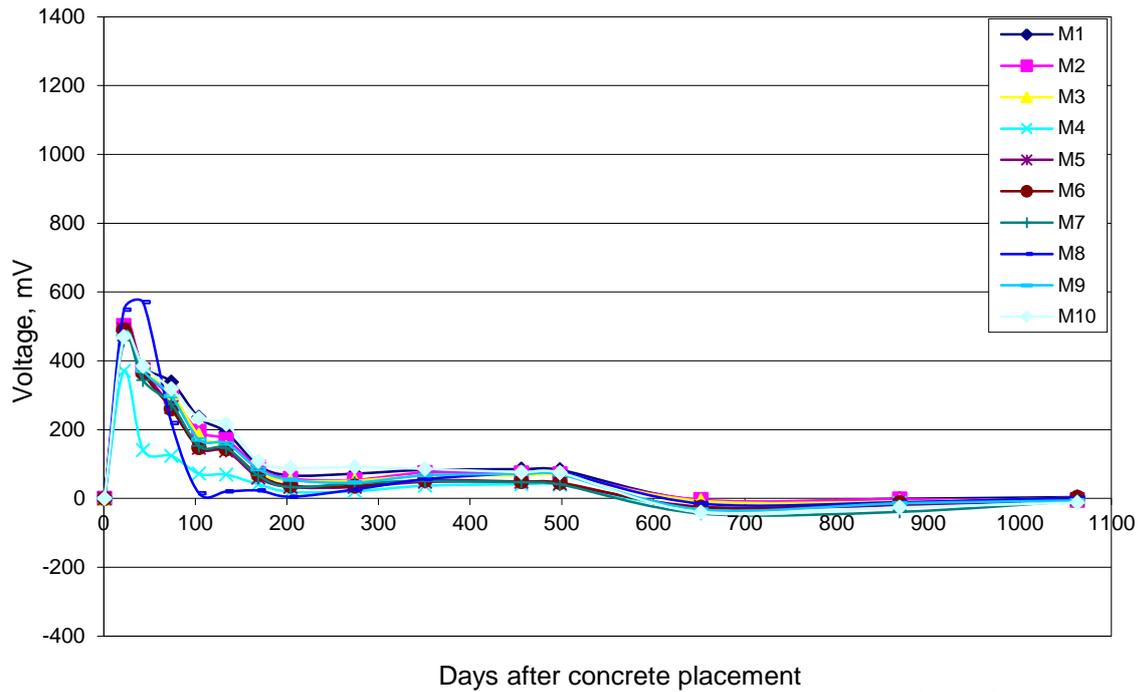
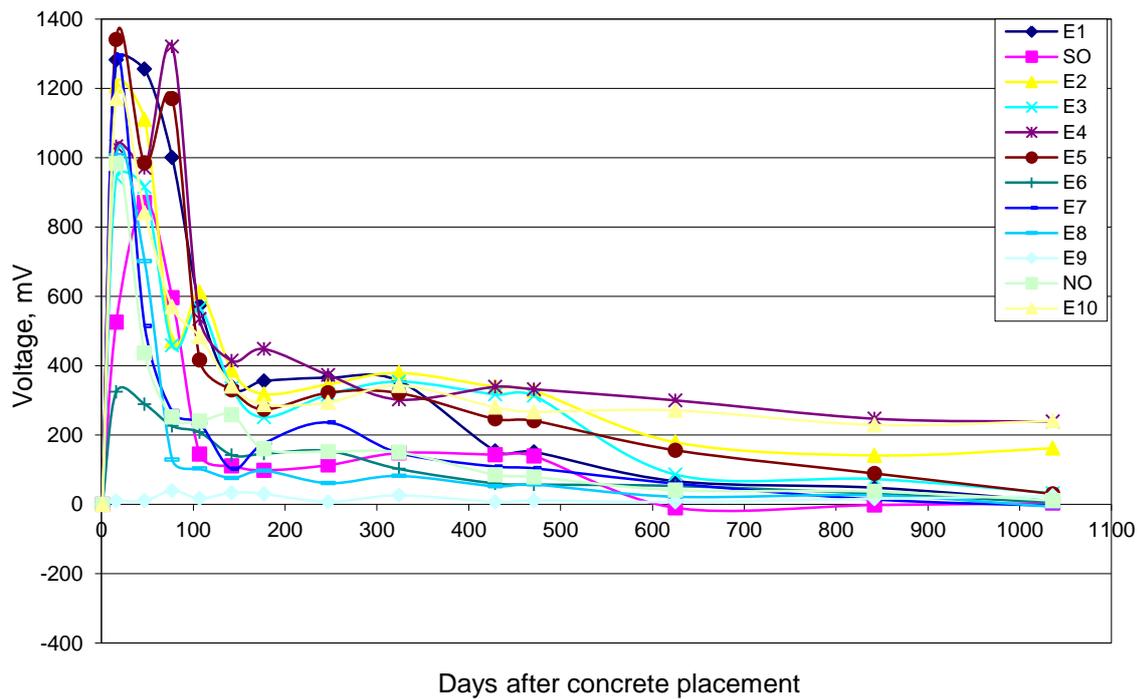
(a) MMFX bridge

(b) Epoxy bridge

Figure 5 – Voltage readings from electrode sensors on instrumented reinforcing steels.

Figures 5 and 6 present the internal voltage and electrical current readings collected from both bridge decks for three years. All MMFX bridge data appear to be as one would expect; although the data increased above 400 mV (see Fig. 5a) at the initial stage, they returned to within the 'normal' range of less than 300 mV after concrete cure (i.e., the initial 'spike' has ceased). Note that even at this initial stage, the electrical current remained below 1000 μ A (Fig. 6a). At approximately three months after concrete placement, all voltage levels for the MMFX bridge dropped steadily and remained within 'normal' range and stayed less than 100 mV. At this point, it appears that there is no ongoing corrosion activity. The epoxy coated reinforcing steels, on the other hand, behaved somewhat unexpectedly. Readings on the Epoxy bridge were higher (about two times higher than the readings on the MMFX bridge) than originally expected. During the initial stage, shortly after concrete placement, some of readings increased over 1200 mV (Fig. 5b). Although these high data readings dropped below 400 mV, some of readings (E2, E4 and E10) were still above or close to 200 mV. Theoretically, there should be nearly zero readings if the reinforcing steel is coated perfectly; steel will be perfectly protected without any 'contact' between the coated steel and the concrete. As shown in Figs. 5b and 6b, however, it is speculated that the 'contact' had been made on some of the specimens being monitored. This is an indication that there was at least one or more defect (i.e., coatings may have been nicked and/or scratched during the process of layout) in the epoxy coating on some reinforcing steels.

Overall, the field monitoring data indicates that corrosion-related measurements were lower for the MMFX bridge than for the Epoxy bridge. Some of the reinforcing steels (E2, E4, and E10), in particular, showed relatively high data readings. However, no significant corrosion activity was observed in either bridge deck; electrical current readings have stayed close to zero after concrete cured as shown in Fig. 6. Visual inspections

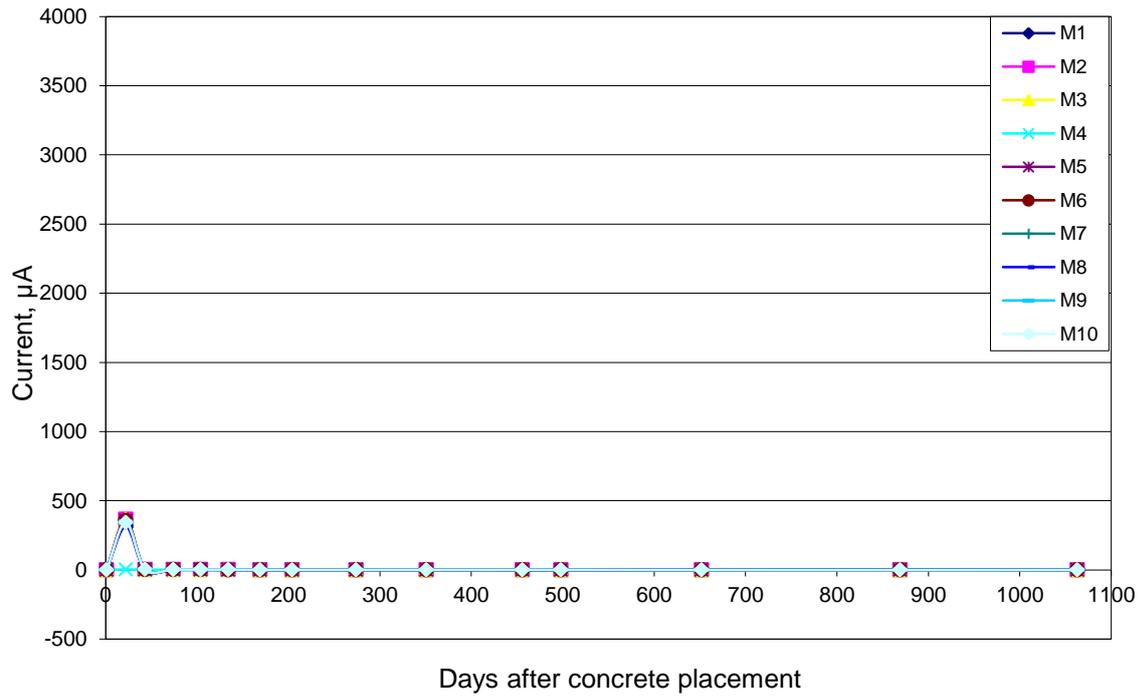
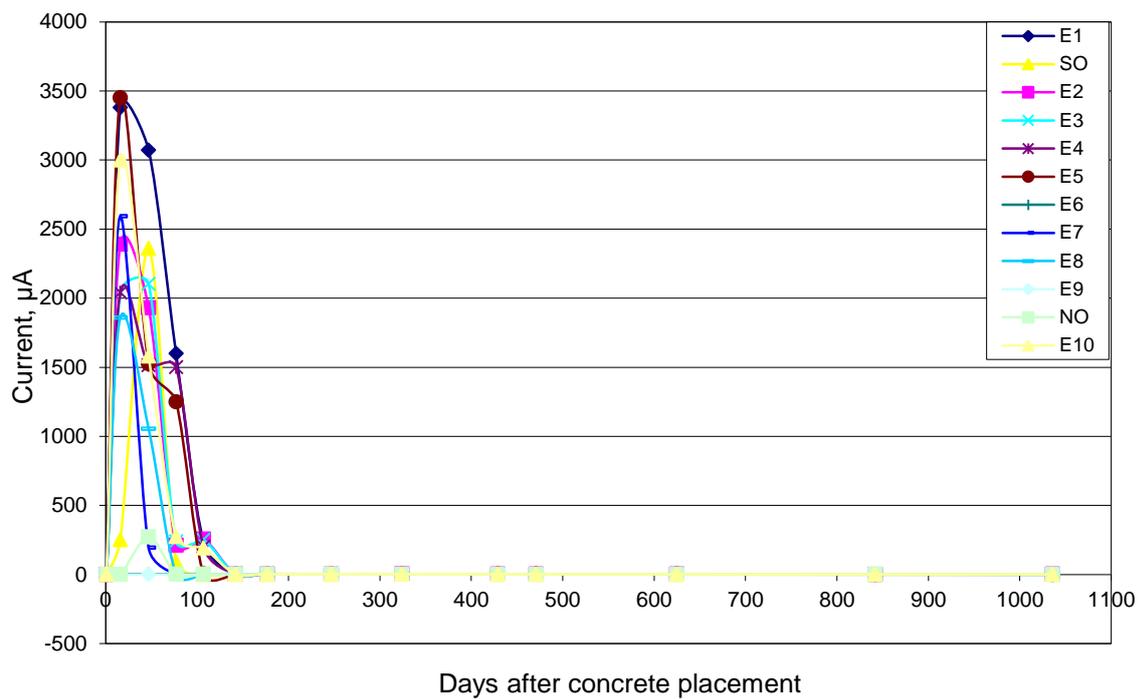
(a) MMFX bridge

(b) Epoxy bridge

Figure 6 – Electrical current readings from electrode sensors on instrumented reinforcing steels.
