RECONSTRUCTION AND REHABILITATION OF BUILDINGS

ABSTRACT

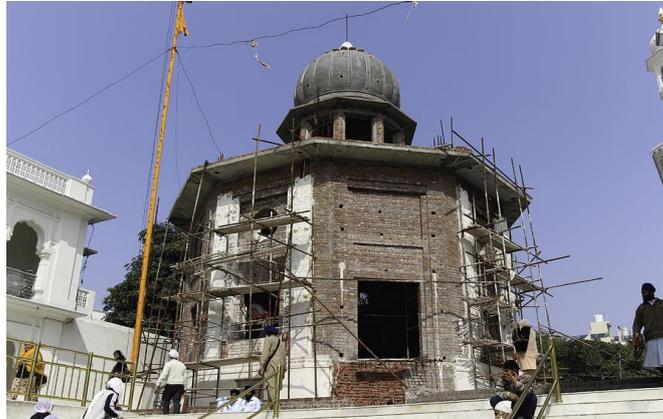
Fig. 1. Reconstruction work inside the golden temple

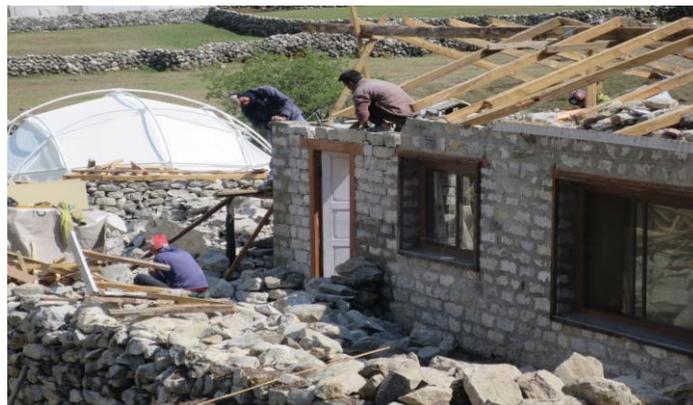
Fig. 2. Reconstruction work after earthquake in Nepal

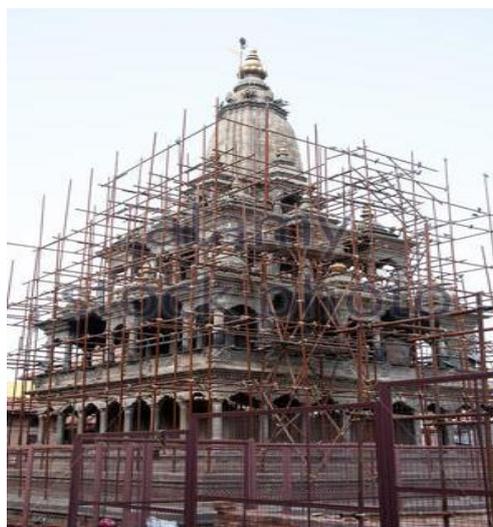
Fig.3. scaffolding building for repair and reconstruction

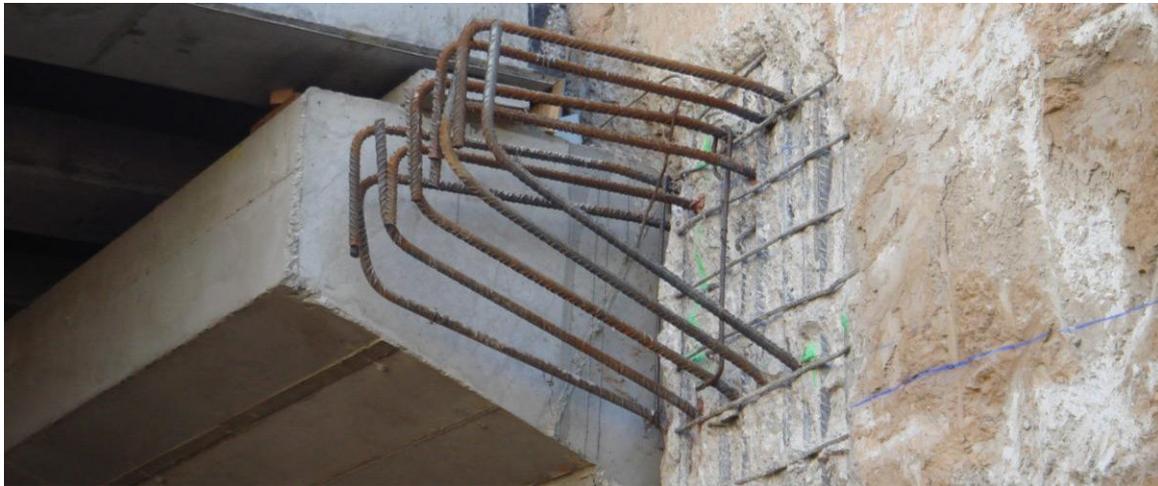
Fig. 4. Visual inspection of structure

Before carrying out detailed investigation, the distressed structure should be inspected visually Specially the joints, nature of distress i. e. cracking, any deflection & other valuable information which may find relevance while going for NDT evaluation.

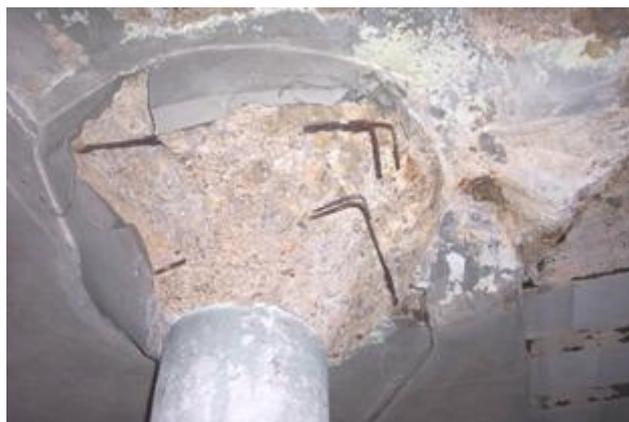
Fig. 5. Signs of deterioration of concrete

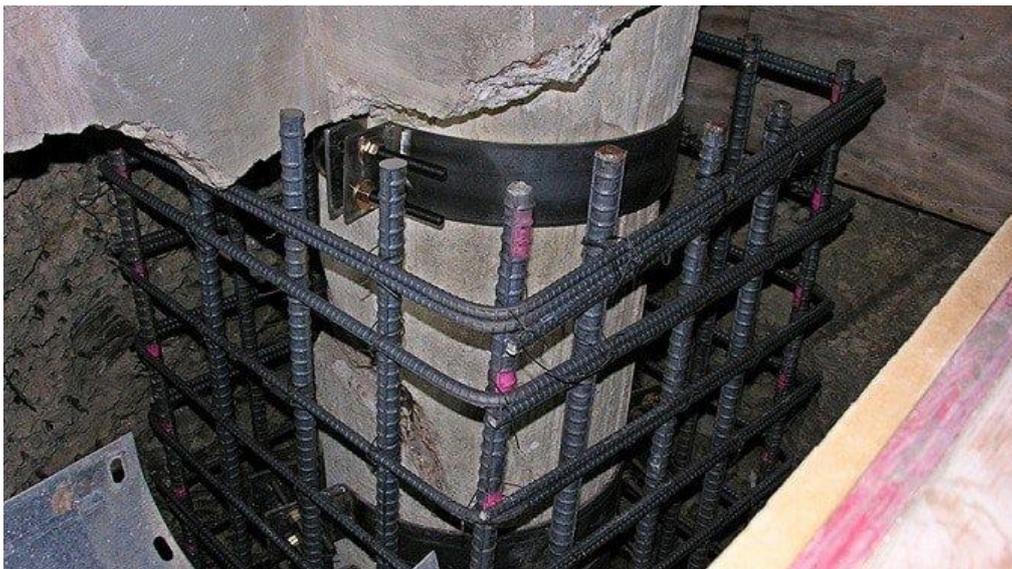
Fig. 6 repair and rehabilitation of structure for failure and defects

1. Restoring & preserving Passivity
2. Restoration of damaged reinforced concrete
3. Consolidation of columns, beams by pressure grouting low viscous epoxy.
4. Jacketing of columns using microconcrete
5. Wrapping & coating with carbon fibre
6. Finally protective coating on the surface

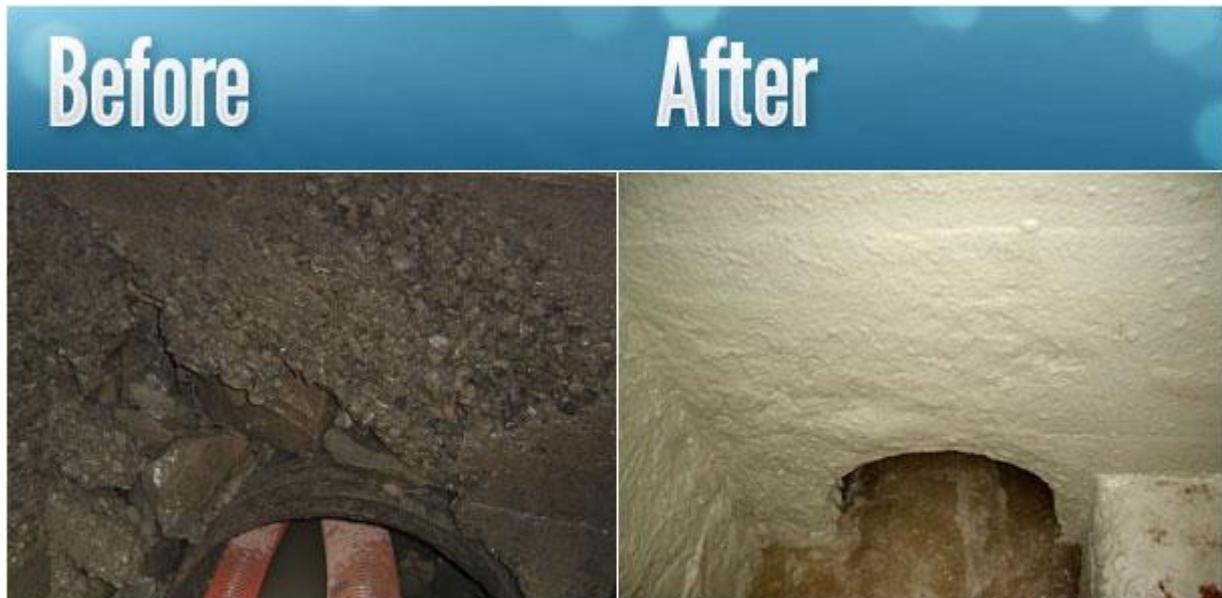
Fig. 7. Rehabilitation of manhole
