## Health Monitoring of Existing Structure By Rebound Hammer. Analysis & Research.

In this paper an institutional building is taken into account and various sections are checked by the use of Rebound Hammer. The aim of this paper is to give different retrofitting techniques to make the structure safe.

#### **POINTS OBSERVED AND VARIOUS REMEDIES GIVEN AFTER CONDUCTING DETAILED STRUCTURAL AUDIT OF THE INSTITUTIONAL BUILDING:-**

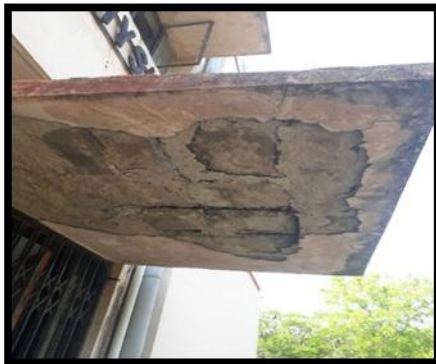
Spalling of Concrete and Excessive Deflection reinforcement is Of chajja

- **Repair chajjas by grouting and where situation is beyond repairable condition, replace there with new chajjas. Refer attached drawings for details.**

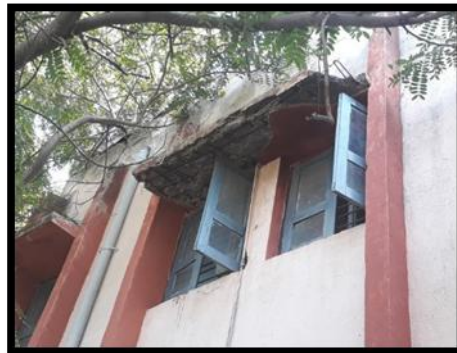
Slab plaster is fallen out and visible

- **Remove the bulged out plaster surface.**
  - **Carry out hacking on the concrete surface and then provide thin layer of putty or paint.**
- 23) The porch slab has deep cracks along the length. The plaster and the concrete spalling can be observed. The cantilever porch has also undergone deflection
