STUDY OF ANTHROPOGENIC IMPACTS OF SILTATION IN WULAR LAKE (JAMMU AND KASHMIR)

Dr. Asiya Nazir

ABSTRACT

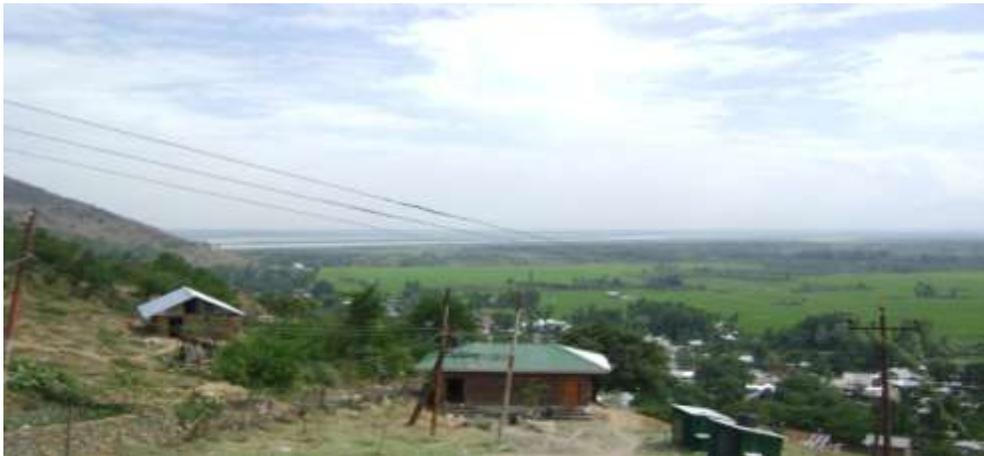
Photo 1.1 Steep gradient and almost flattened morphology of the Wular lake

The natural erosive processes have been accelerated due to the physical deterioration of the hill slopes around the Wular catchment. The Wular Lake, today, is overexploited due to the land acquisition and is subjected to large siltation rates. It is mainly because of deforestation and creation of residential zones wherever hilly tracts have been affected by man's interference. The very existence of the Wular Lake is, therefore, threatened due to overexploitation of resources and encroachment by burgeoning population (**Photo 1.1**).

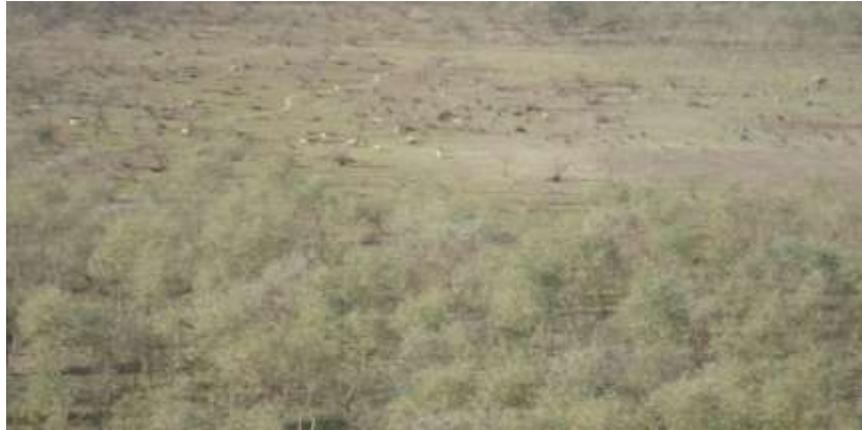
Photo 1.2 Grazing activities in the encroached land within Wular catchment

d. **Degradation of high altitude pastures:** The pastures under the Wular direct catchment are under constant pressure of the nomadic grazers (**Photo 1.2**) According to the official government reports, 2000 ha of the pasture land, today, is identified as severely eroded, 2,500 ha as moderately eroded and 4,100 ha as slightly eroded (Report, CMAP)

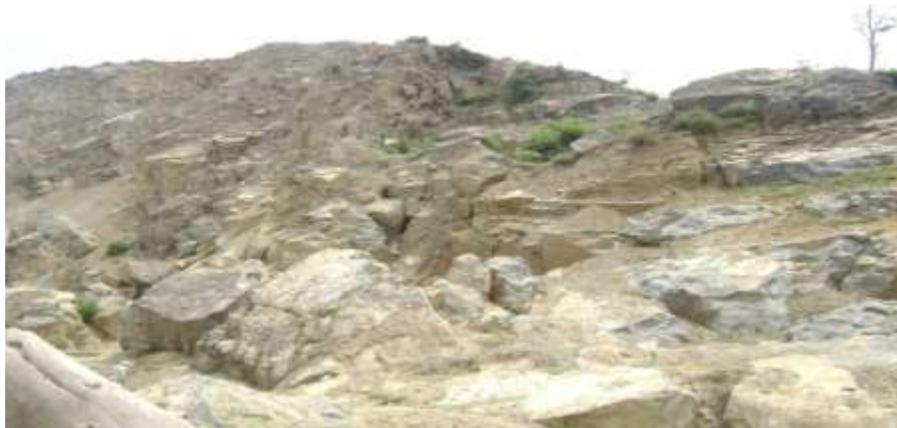
Photo 1.3 Mining activities in Pir Panjals.

e. **Quarrying:** Quarrying is an intensive activity in the direct catchment, particularly along the Bandipora-Srinagar road in the Sadarkote sector. During the course of survey, a number of stone quarries in the Wular direct catchment, especially concentrated in Sadarkote Bala were observed (**Photos 1.3** and **1.4**). These quarries run throughout the year and dislodge tremendous quantity of loose detritus into the lake bed during the monsoon seasons. Besides these, sand and bajri mining is also practiced intensively within the Madhumati river catchment. These activities severely alter the natural siltation profile of the catchment. Degradation of the catchments has contributed to high levels of erosion. Similarly, remote sensing surveys on slopes and land-use patterns reveal that 43% and 19% of the catchment area falls under moderate to high erosion categories, respectively.

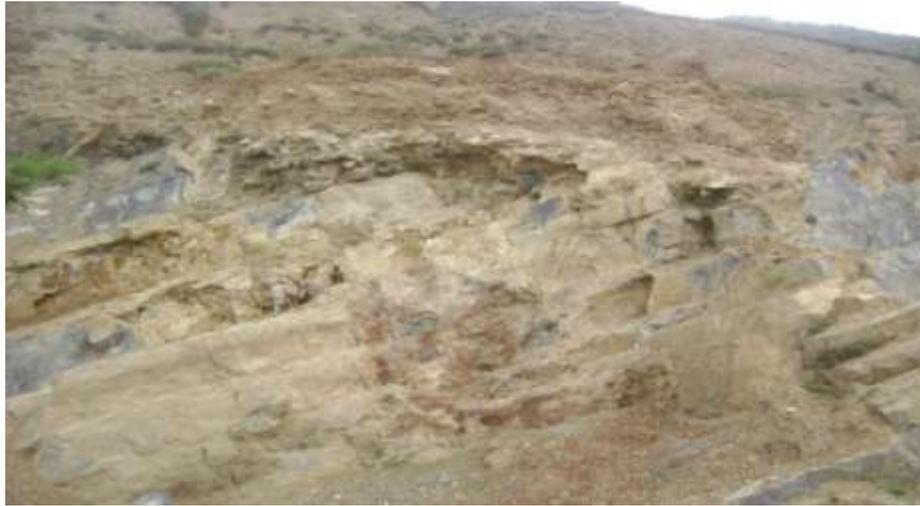
Photo 1.4 Quarrying practices along the steep slopes

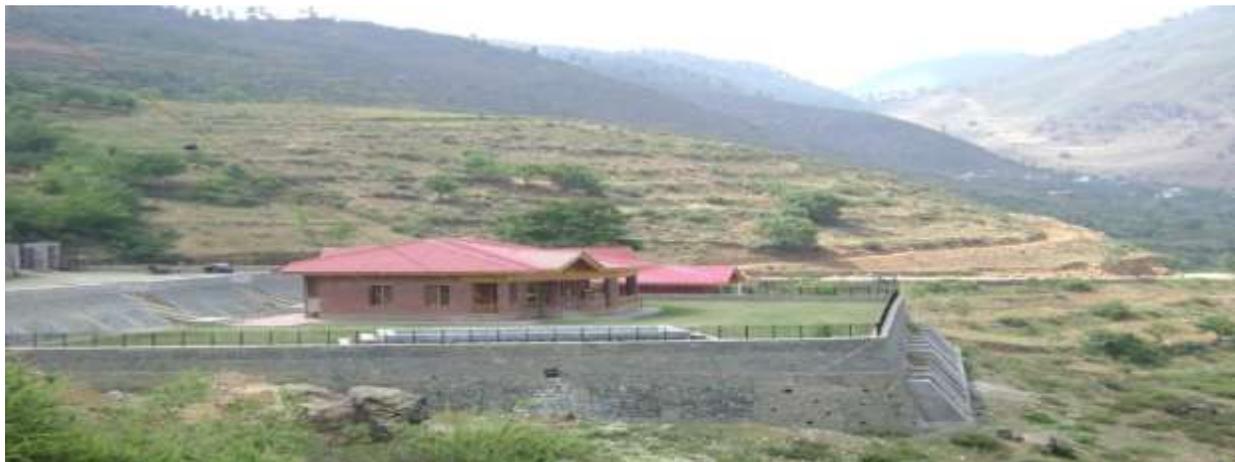
Photo 1.5 Encroachment of Tourism Department along the lake catchment which has led to deforestation and unstable hill slopes

h. **Encroachment of Wetland area by various enterprises:** Many government, as well as, private enterprises have encroached upon the wetland catchment, thereby shrinking the original area and making the slopes more vulnerable to erosion, wherever such landforms are occupied (**Photo 1.5 and 1.6**). Such practices should be thoroughly checked by the concerned departments and strict actions should be taken against the parties involved.

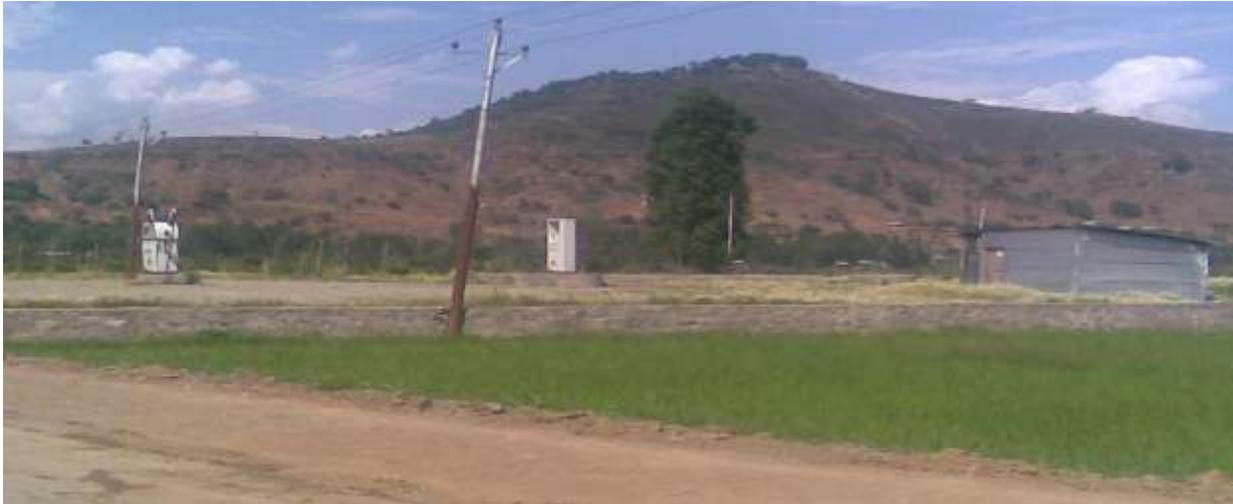
Photo 1.6 Encroachment of a Petrol pump within the premises of Wular

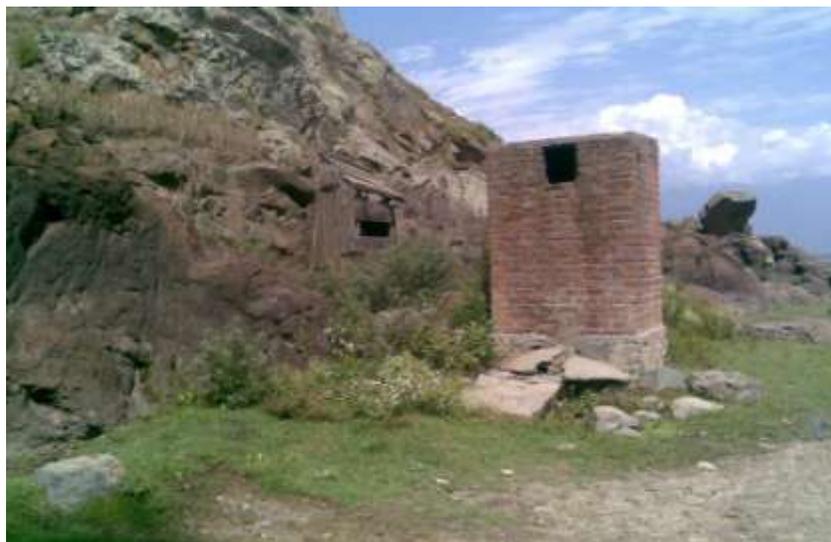
Photo 1.7 Lavatories with open drains entering the lake area

- a. Lack of sanitation facilities:** Absence of adequate sanitation and safe drinking water facilities have led to severe health hazards, particularly for the lakeshore communities. There is a sharp rise in the water borne diseases such as gastroenteritis, jaundice and diarrhoea. Presently, less than 2% of the households living in the lakeshore villages have access to safe sanitation facilities and 42% use untreated water from Wular for domestic purposes rendering them highly vulnerable to water borne diseases and infections (**Photo 1.7**).

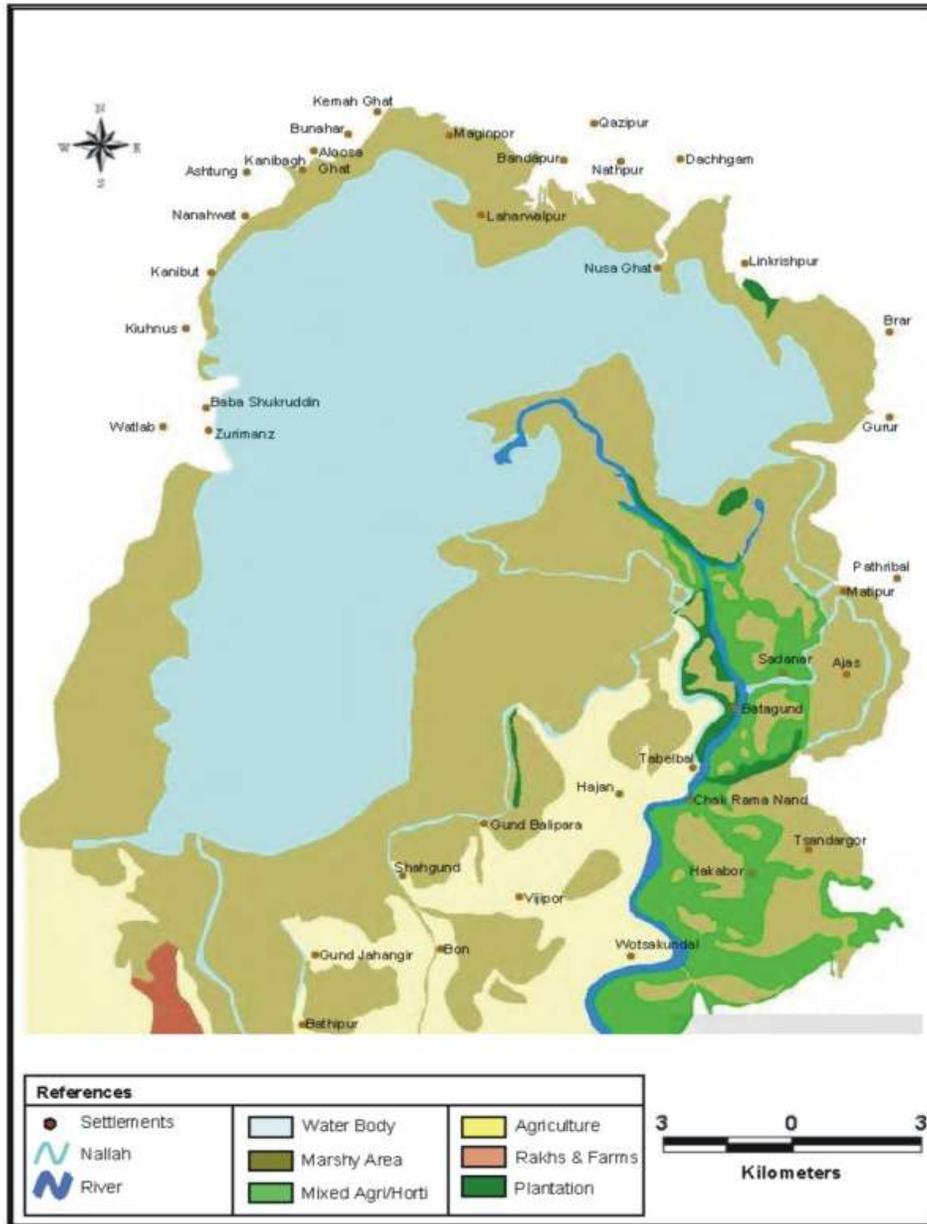
Fig. 1.3 (a) Land-use (1911)

A comparison of the SOI toposheets of 1911 and the imageries of 2007 indicate an overall reduction in wetland area by 45% (157.74 sq km to 86.71 sq km. {Fig. 1.3 (a,b) and Table 1.1}

Land-use categories	Area (sq. km)		NET CHANGE
	1911	2007	
Water	91.29	75.23	-16.06
Marsh	66.45	11.48	-54.97
Plantation	0.66	27.30	26.64
Agriculture	0.38	44.25	43.87
Settlements	0.43	0.95	0.52
Total	159.21	159.21	
Associated Marshes	58.67	17.67	-41.00
Net Total	217.88	176.88	-41.00

This shows that the water body and marshy areas of the wetland has reduced from about 91 to 75 and 66 to 11 percent respectively with a subsequent increase in plantation, agriculture and settlements, resulting in an overall change of more than 40 percent.
